Situation Photo Log

Thursday, June 28, 2012

Kalamazoo River / Enbridge Spill

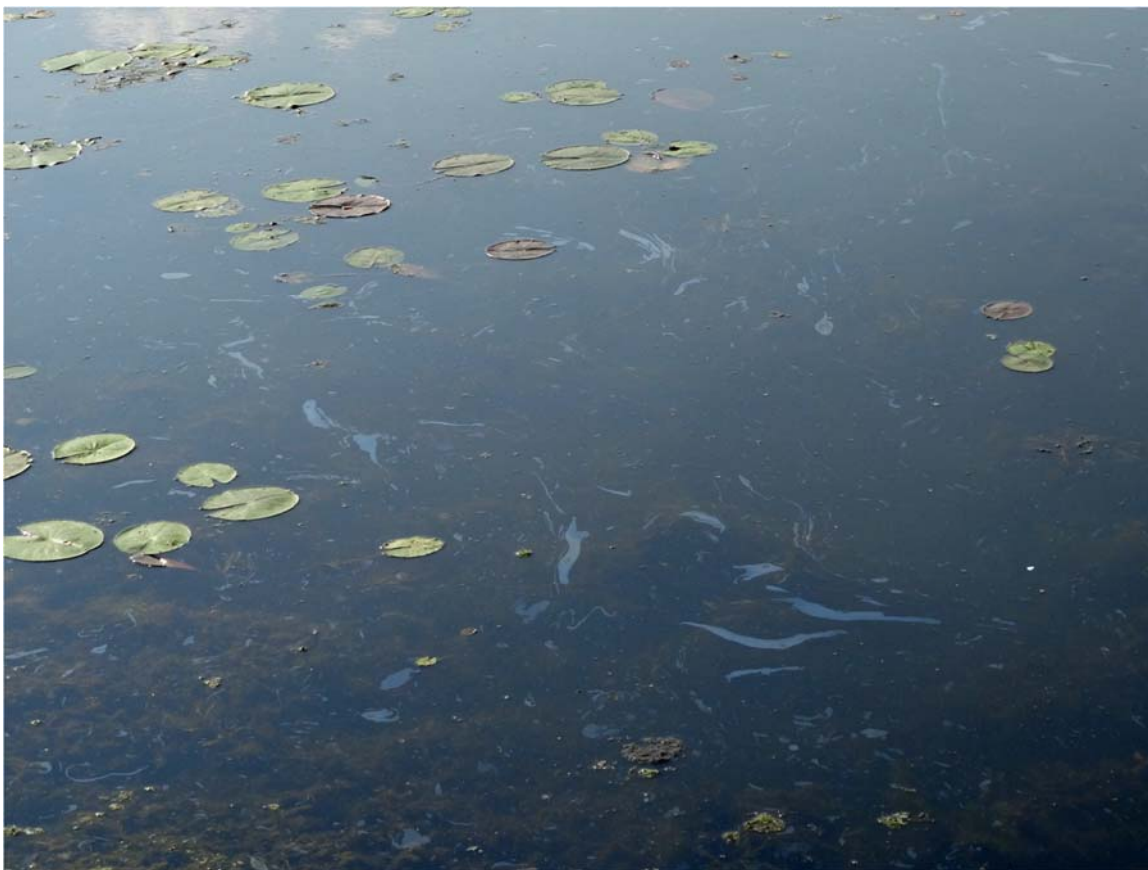
1. MP15.5 South Mill Pond north corner observed sheen.

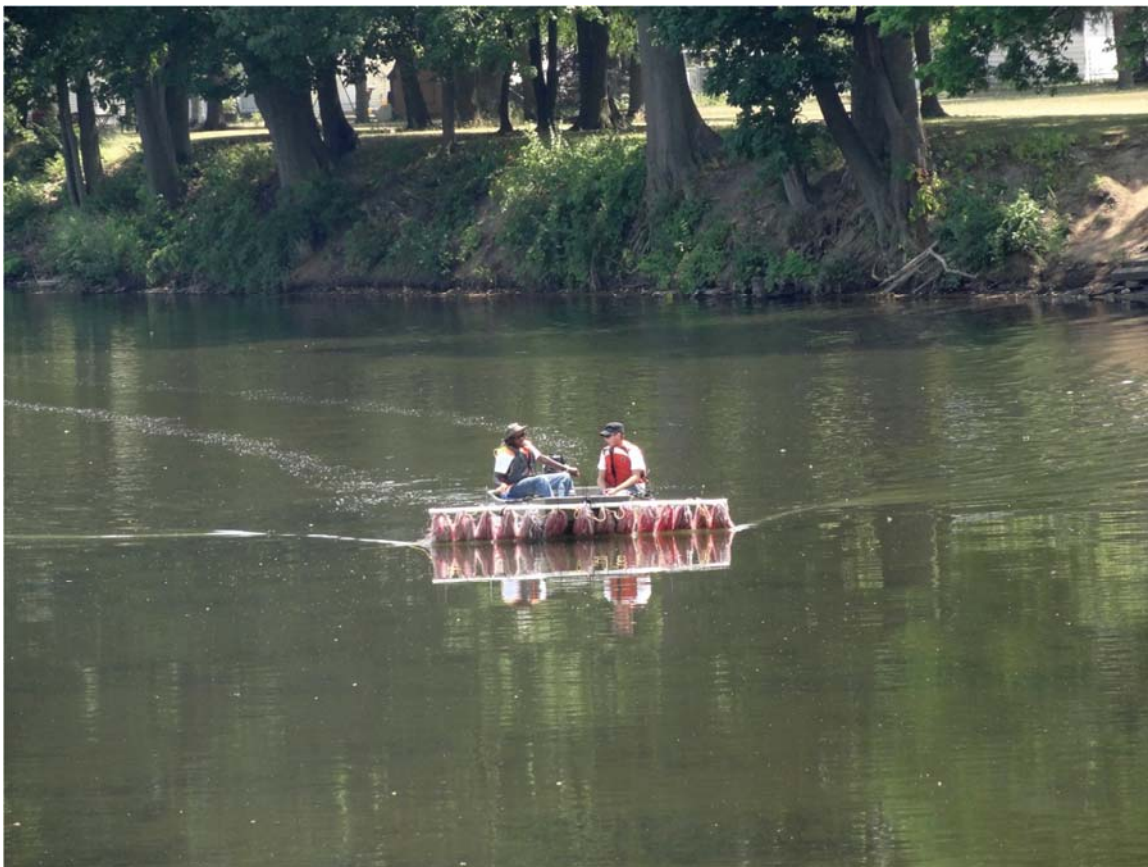
2. MP15.5 Mill Pond sheen sweep observed.

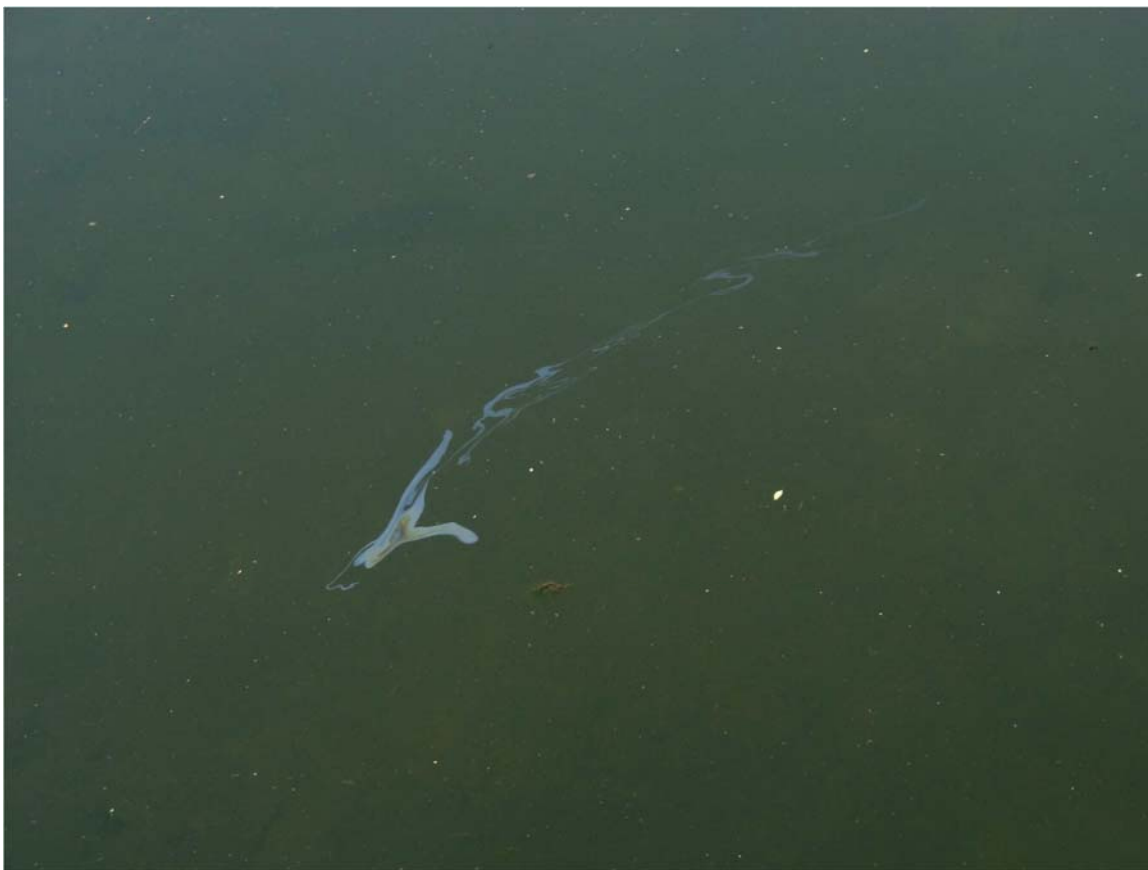
3. MP15.5 South Mill Pond north corner observed sheen flowing out of Mill Pond into river. Operations was notified and sweep boat was observed in the area.

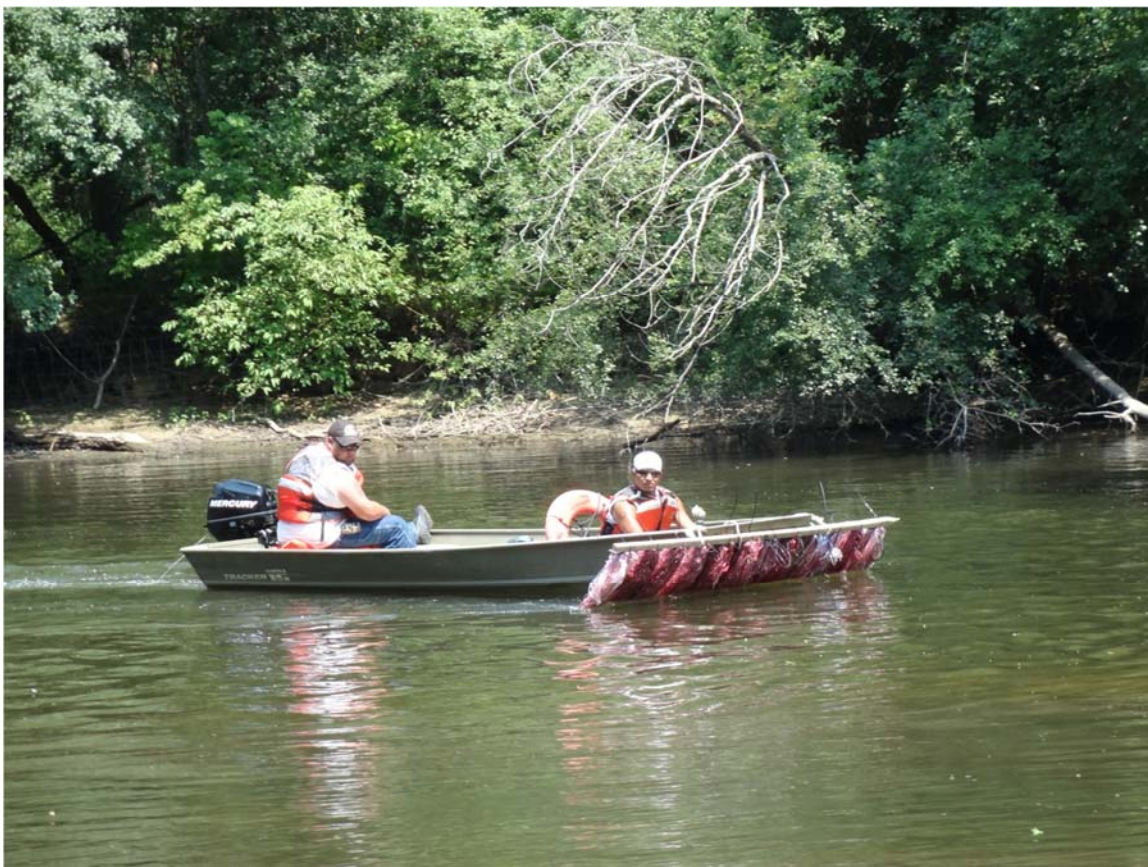
4. Observed sheen sweep boat responsible for routine daily sweeps in MP21.5 – MP30 range.

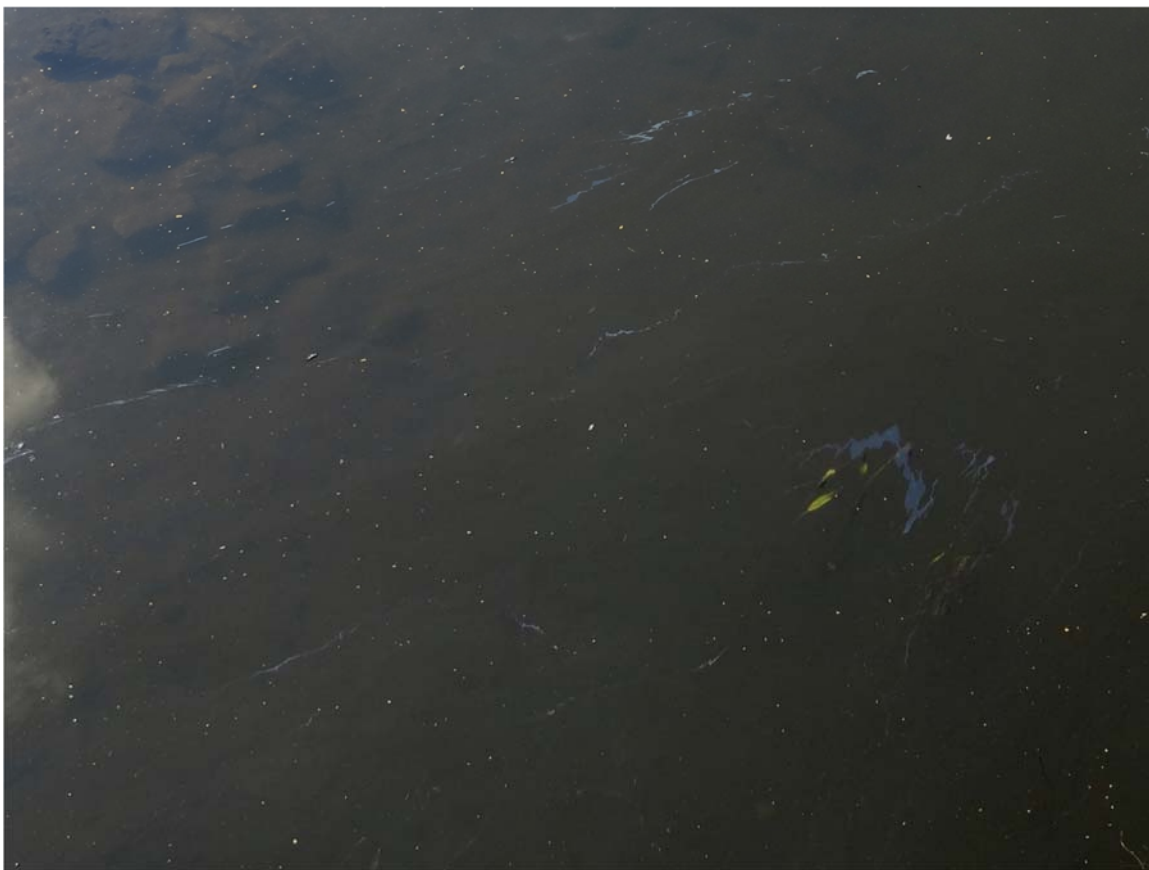
5. MP21.5 Custer Drive bridge sheen observed. Operations was notified and sweep boat was deployed.

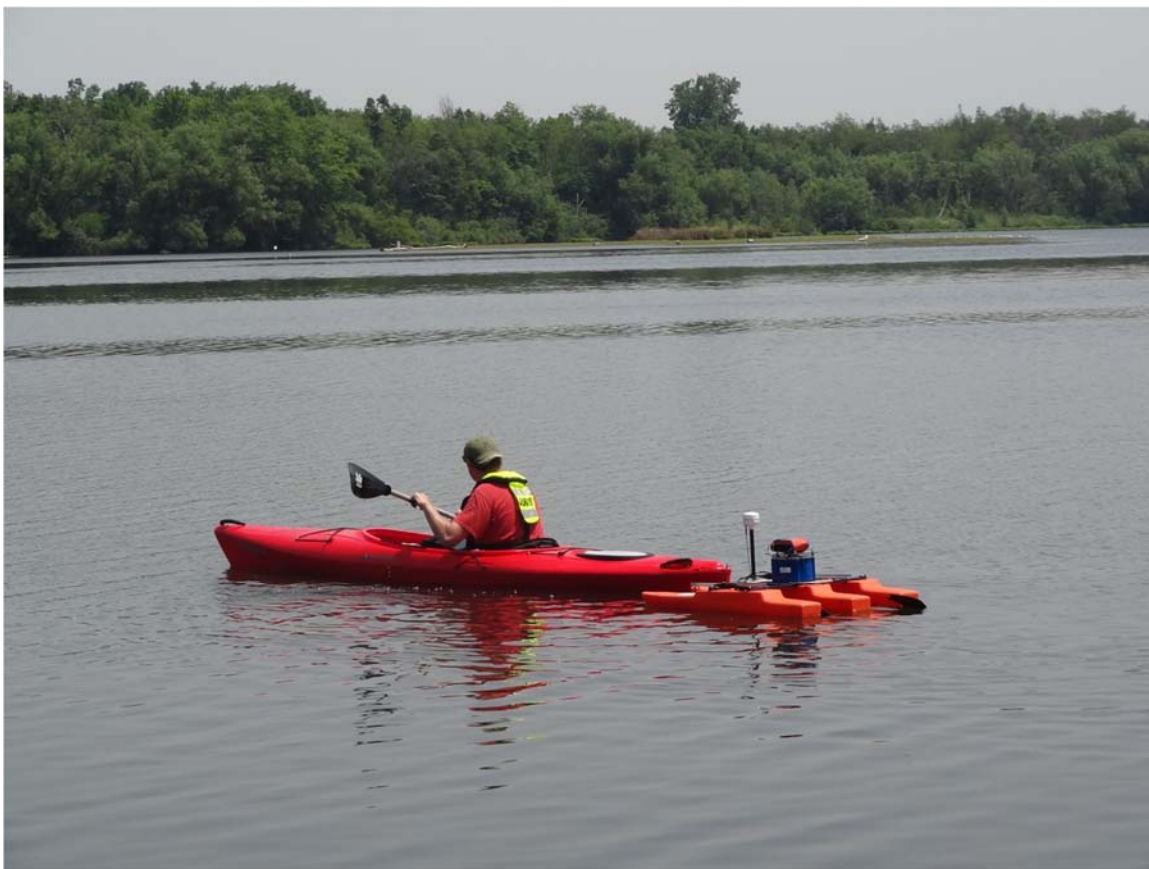
6. Morrow Lake Delta observed USGS taking velocity measurements.

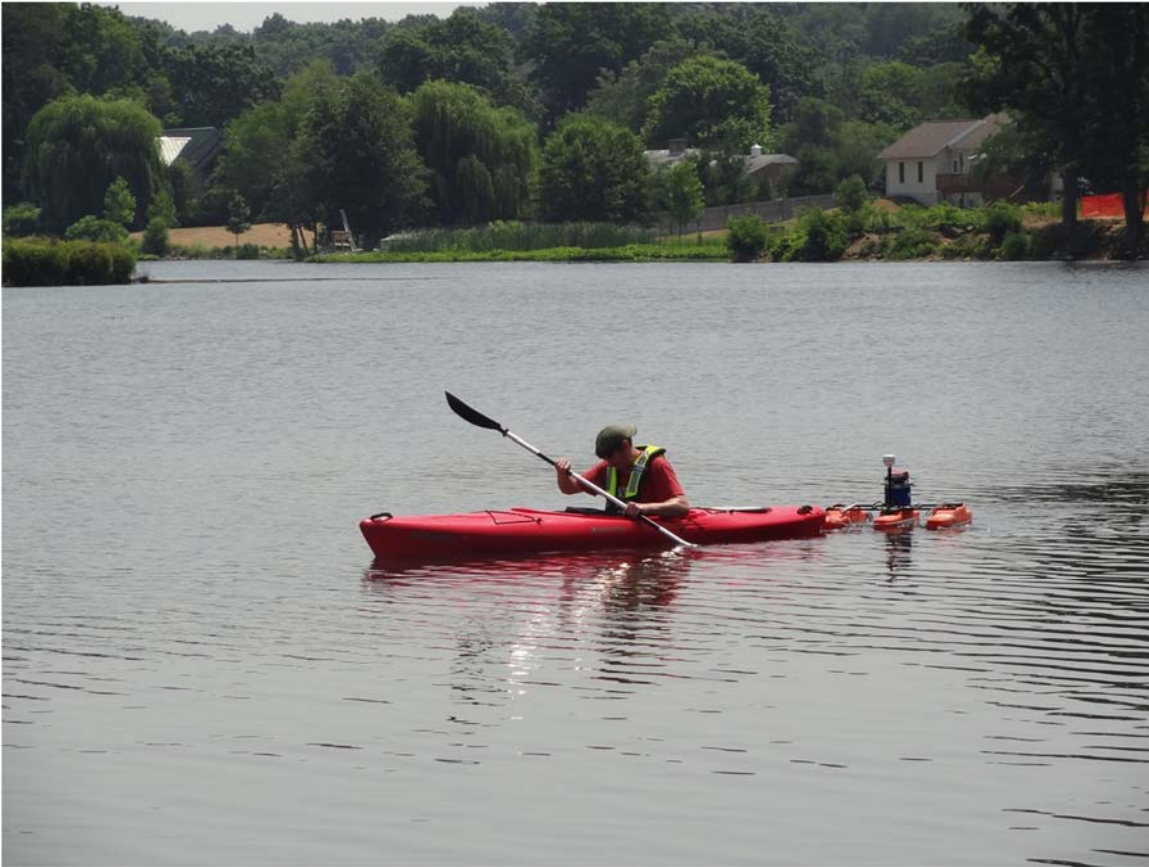
7. Morrow Lake Delta observed USGS taking velocity measurements.

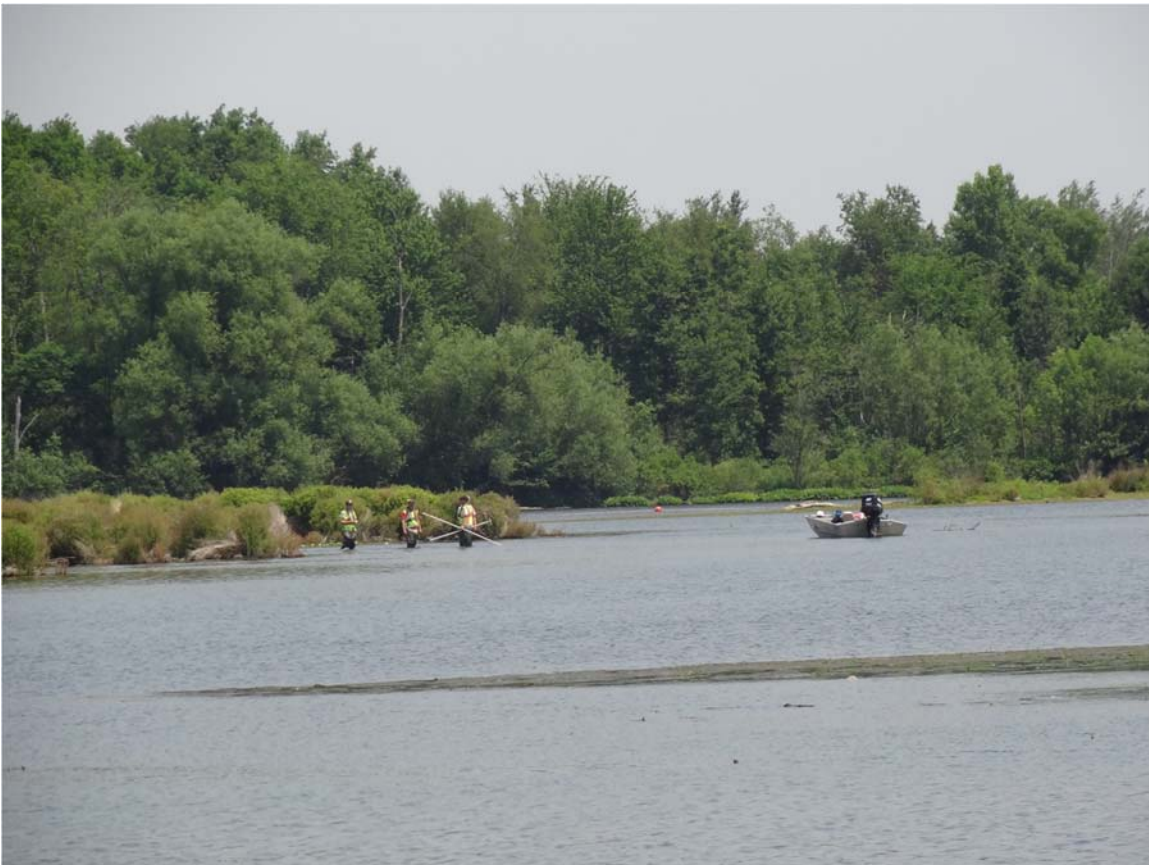
8. Morrow Lake Delta observed poling crew.

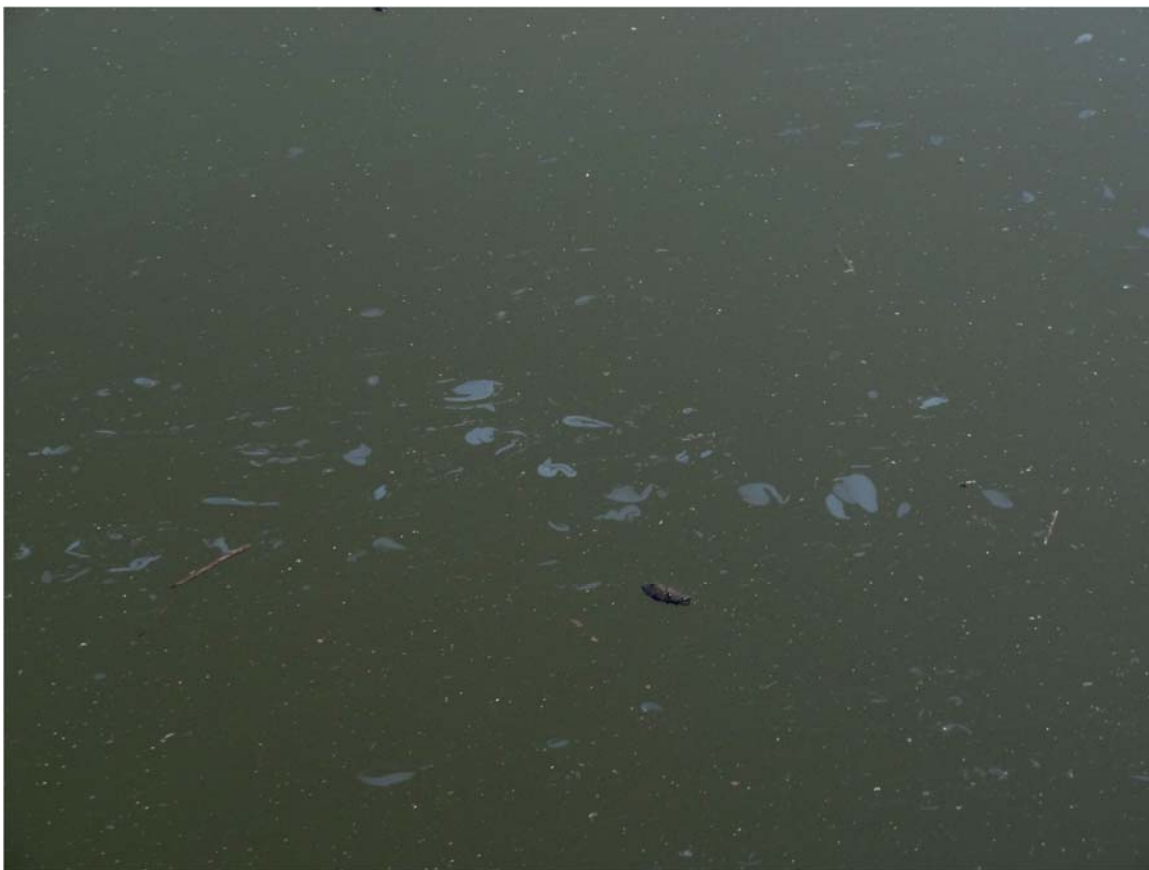
9. MP37.5 Morrow Lake Delta sheen observed. Operations was notified and a sheen boat was deployed.

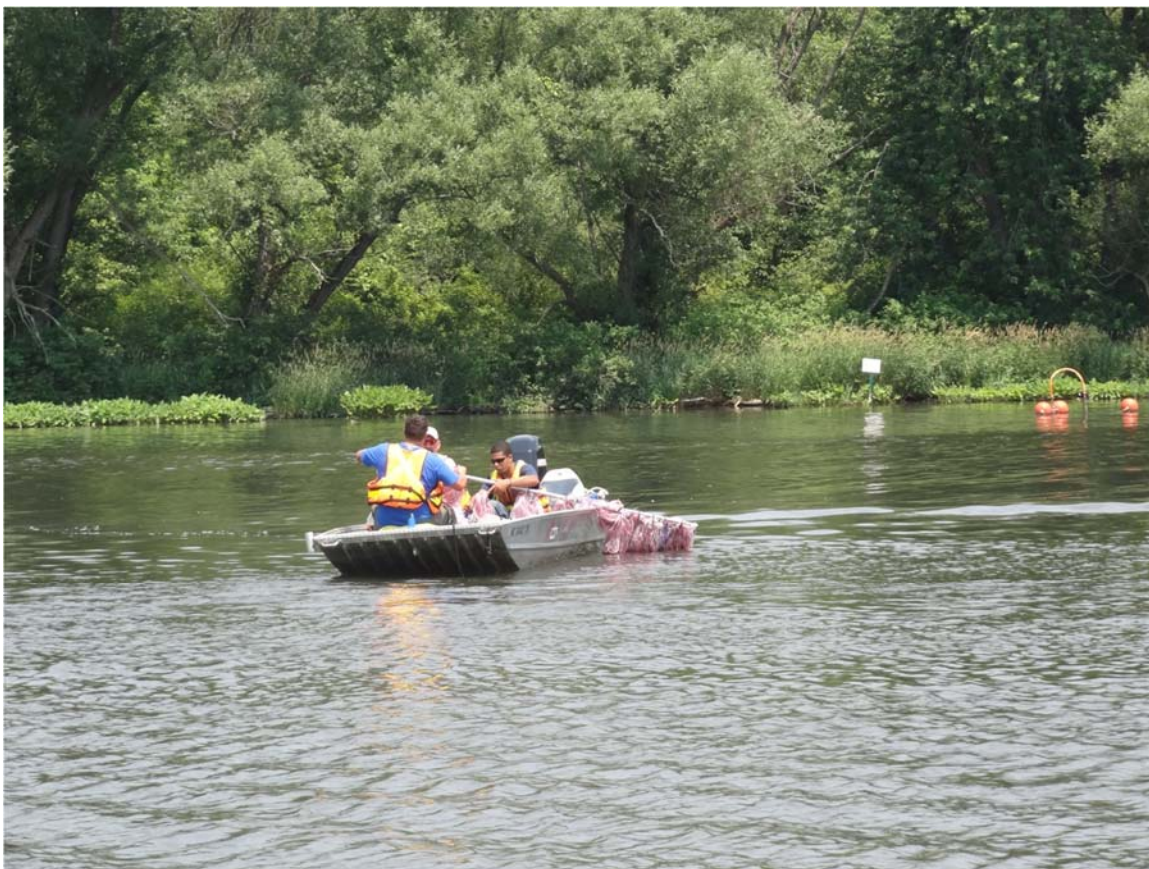
10. MP37.5 Morrow Lake Delta sheen sheen boat deploying to manage sheen.

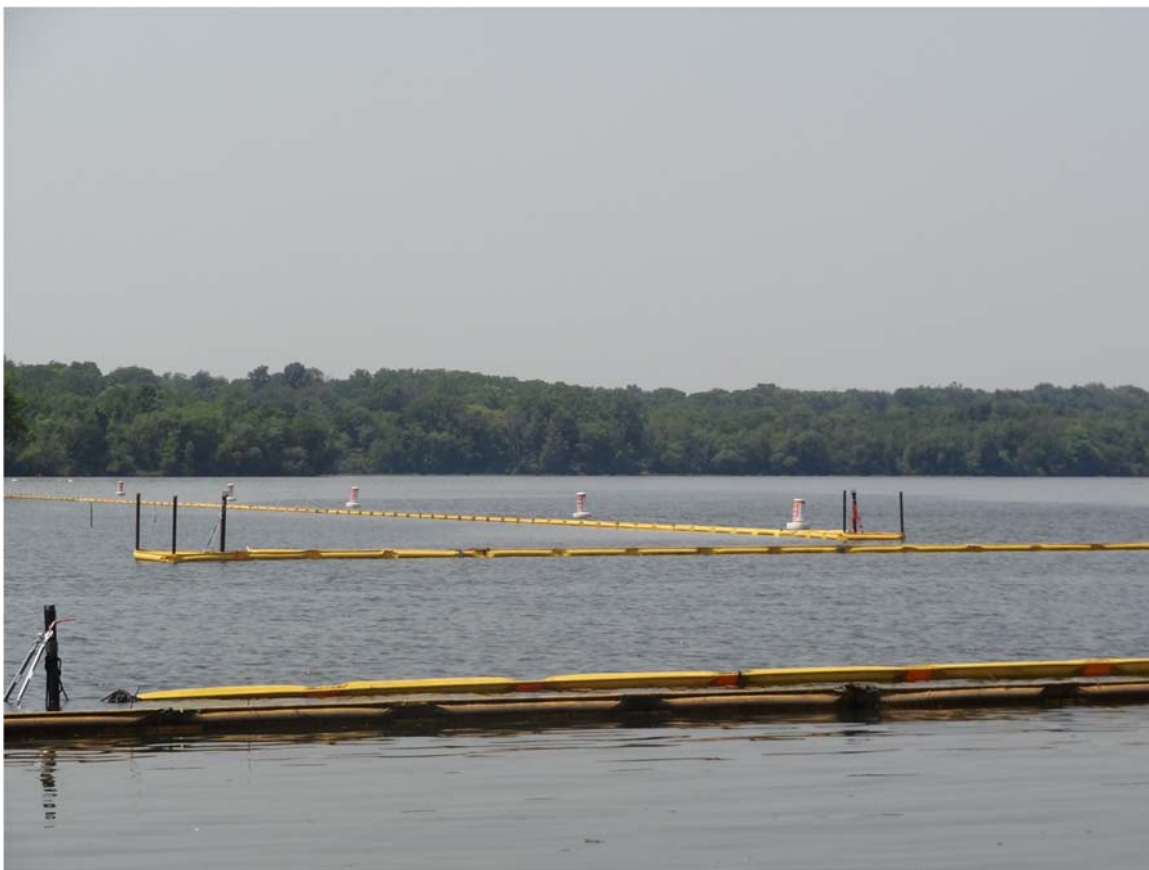
11. MP37.75 Newly installed booms.

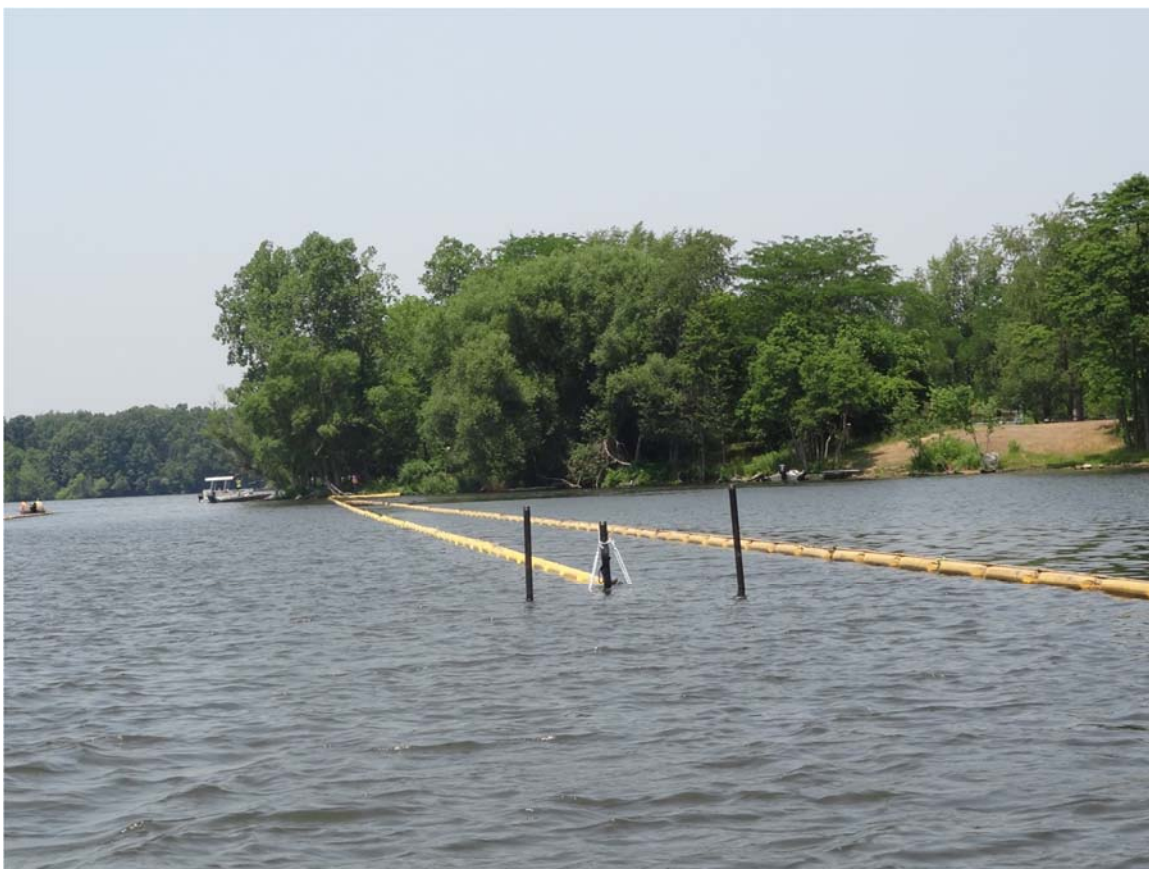
12. MP37.75 Observed boom deployed near E4 control point.

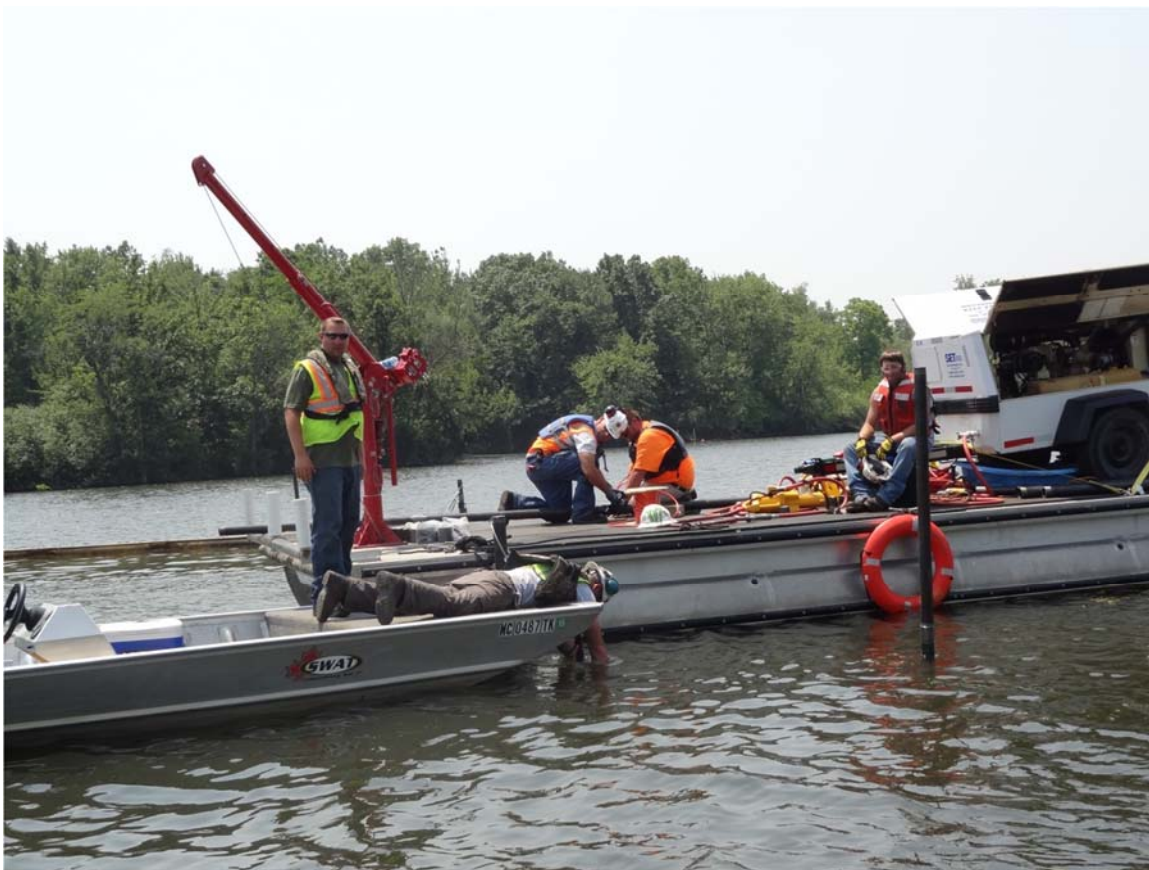
13. Observed crew installing new anchor point for boom.

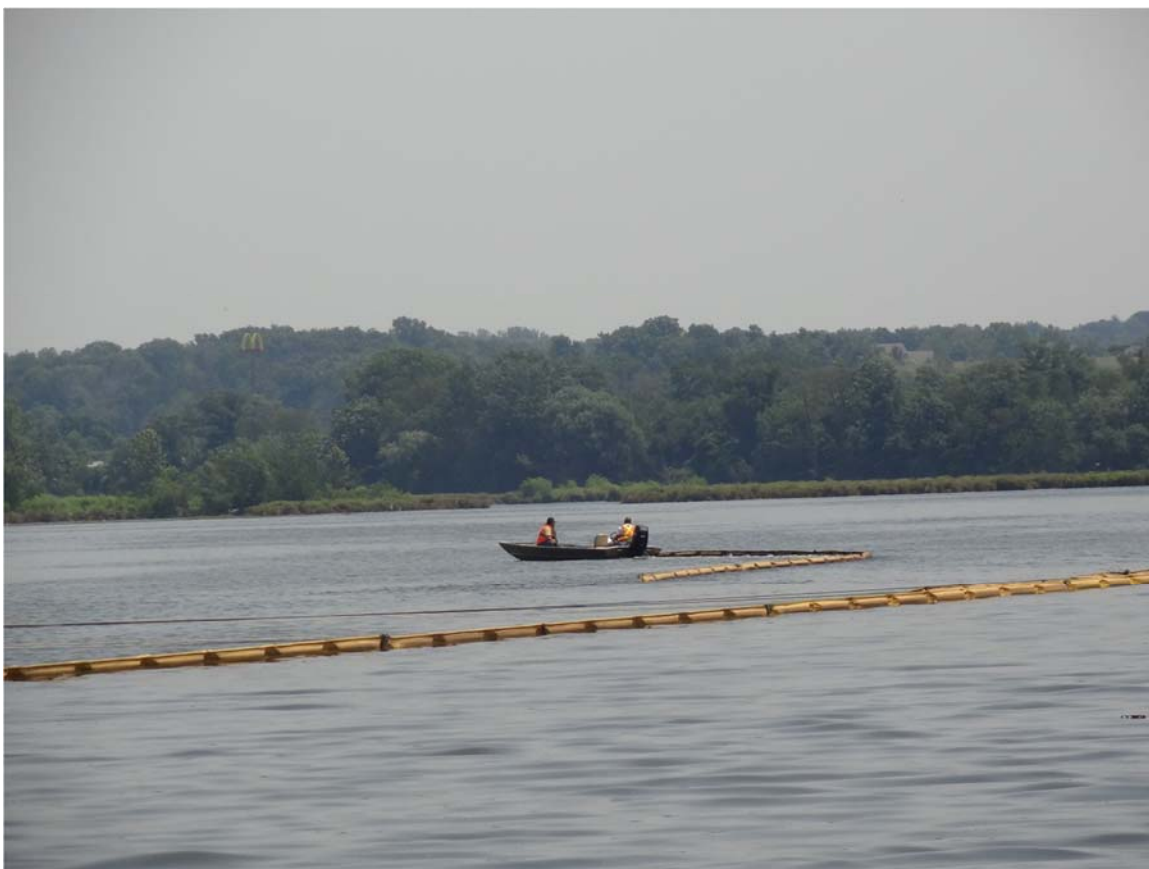
14. Morrow Lake Delta observed crew removing former E4 control point boom.

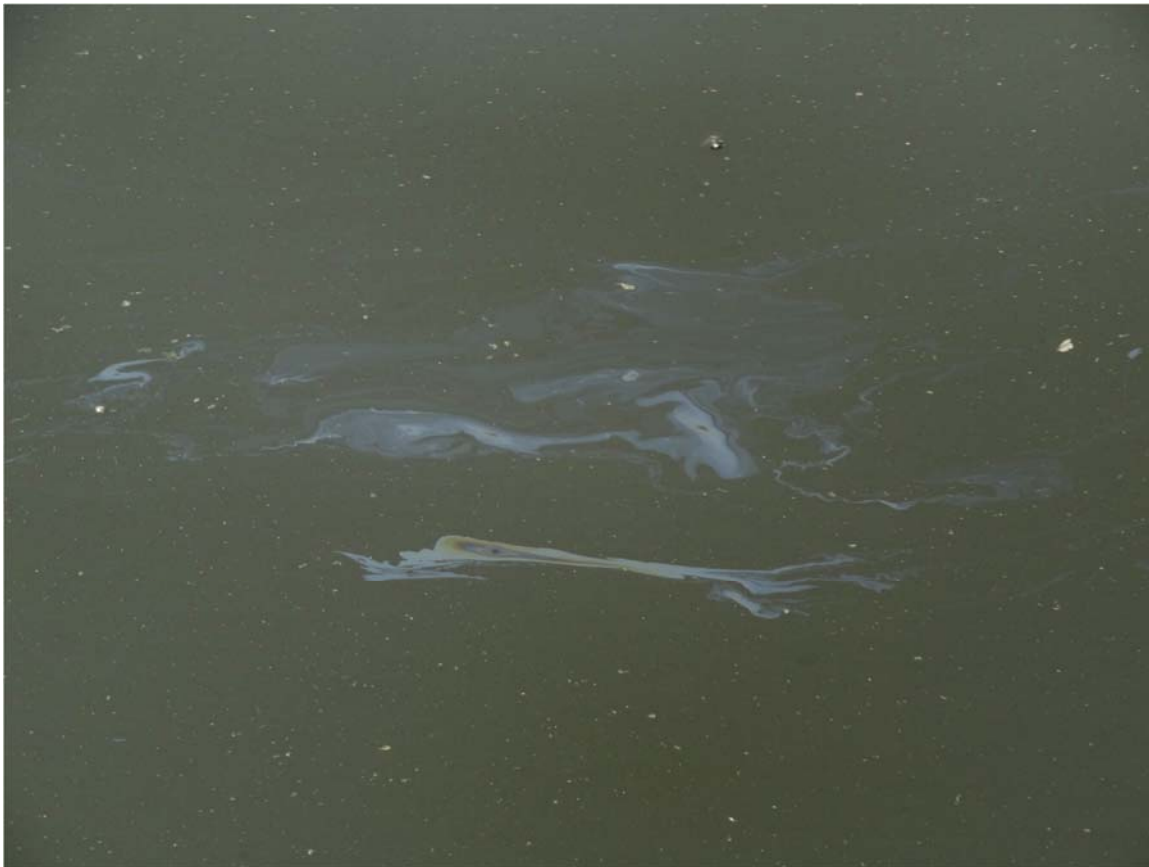
15. Morrow Lake sheen observed.

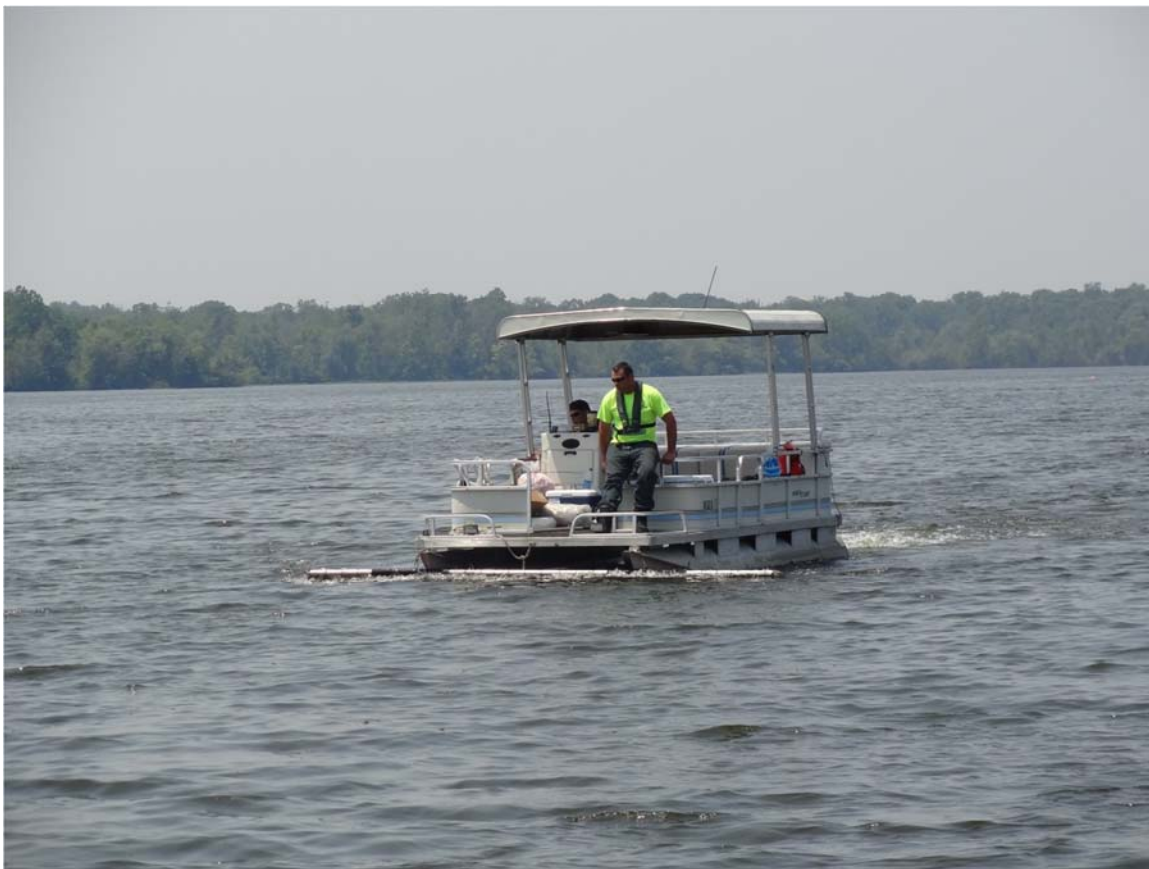
16. Morrow Lake sheen sweep boat responding to sheen sighting.

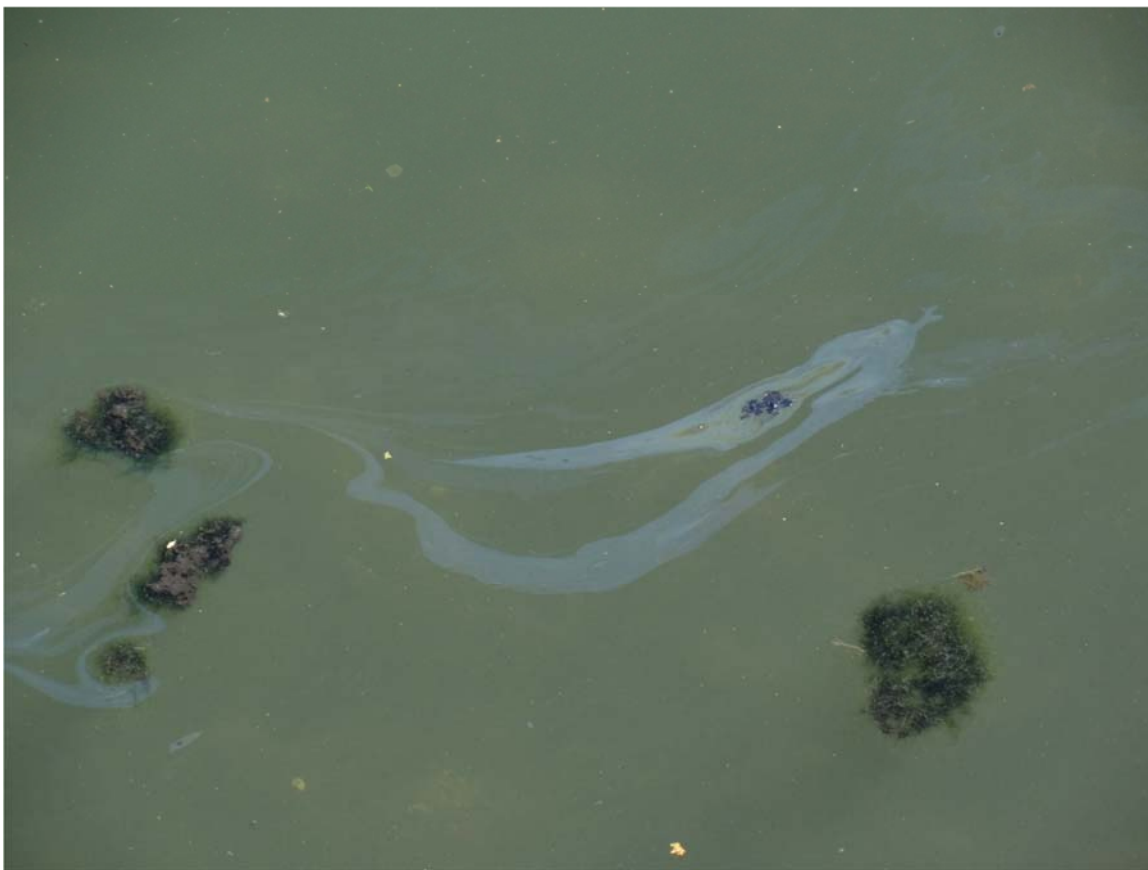
17. Ceresco Dam sheen observed. Operations was notified

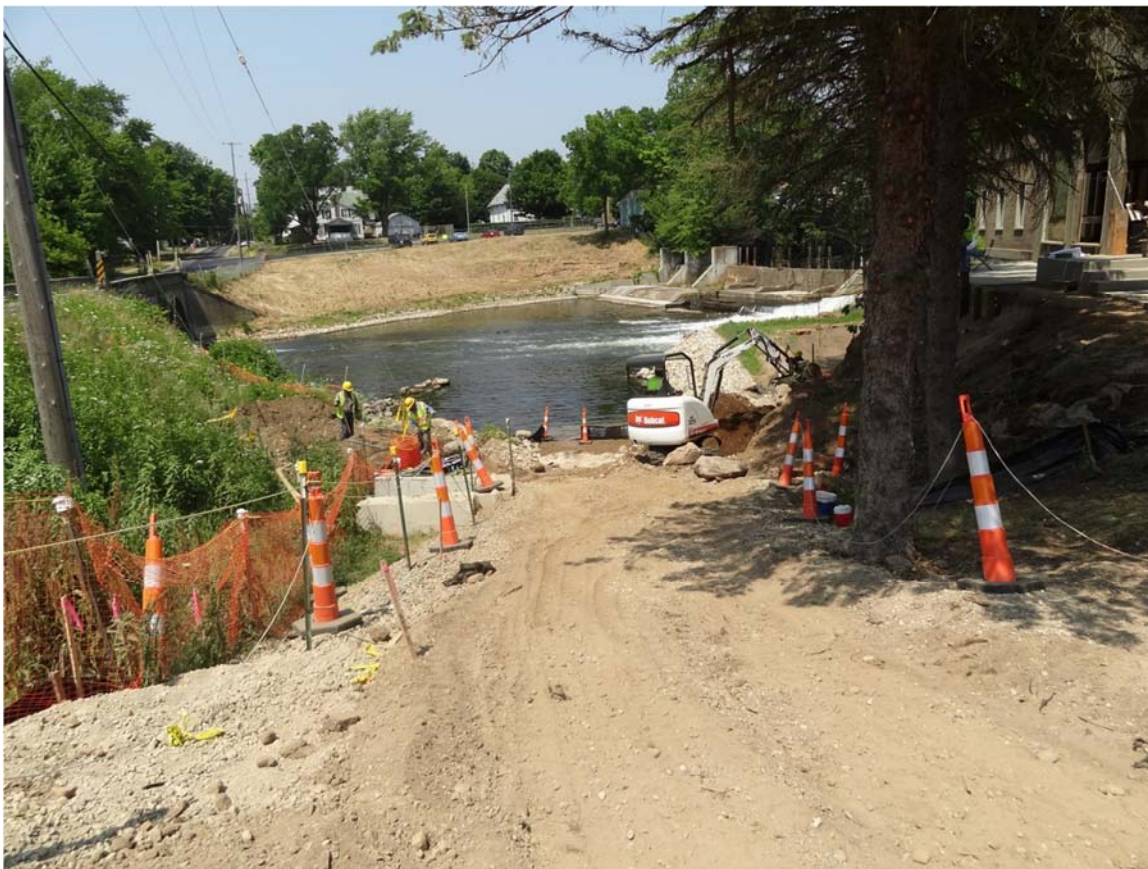
18. Ceresco Dam portage work continued.
